# Metro Regional Government Headquarters Ecoroof 600 NE Grand Avenue, Portland, Oregon

## **PROJECT SUMMARY**

Constructed:	August 2005

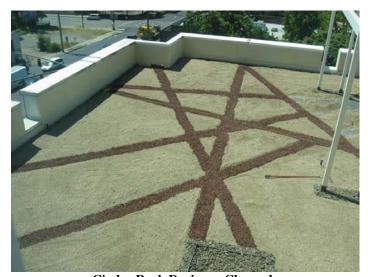
Metro Ecoroof Monitoring Equipment at the Roof Drain

Metro will monitor the performance of the ecoroof for at least 2 years after the ecoroof is fully established. Metro installed two V-notch weirs and water level instruments at the drain on both the ecoroof section and the rock ballast roof test section. The weir dams the water to create a measurement pool, and the pool raises a float off the ground before the water reaches the bottom

of the V-notch. A rain gauge (Unidata, 6506B) was located near the data collection site on the conventional roof, and a flow transducer was installed to measure the irrigation used on the ecoroof during the dry months while the plants are being established. A data logger gathers the information and downloads it. The entire monitoring system is powered by a solar photovoltaic cell.

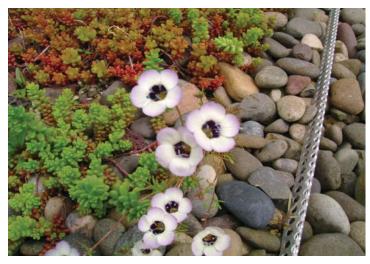
Flowers: Gilia tricolor next to perforated metal edging at roof drain

Sedum grows into a carpet

- Walkway pads (30 inches by 30 inches) were placed to protect the membrane in areas designated for foot traffic (e.g., for access to monitoring equipment).
- Perforated metal edging was used at the main roof drain; this element is optional. No edging
  was used to separate the rock ballast perimeter or the drainage channels from the vegetated
  roof portion.
- A test of the saturated weight of the soil was required to determine the soil depth at 12 pounds per square foot.
