STORMWATER MONITORING TWO ECOROOFS IN PORTLAND, OREGON, USA

Doug Hutchinson, Peter Abrams, Ryan Retzlaff, Tom Liptan

City of Portland, Bureau of Environmental Services

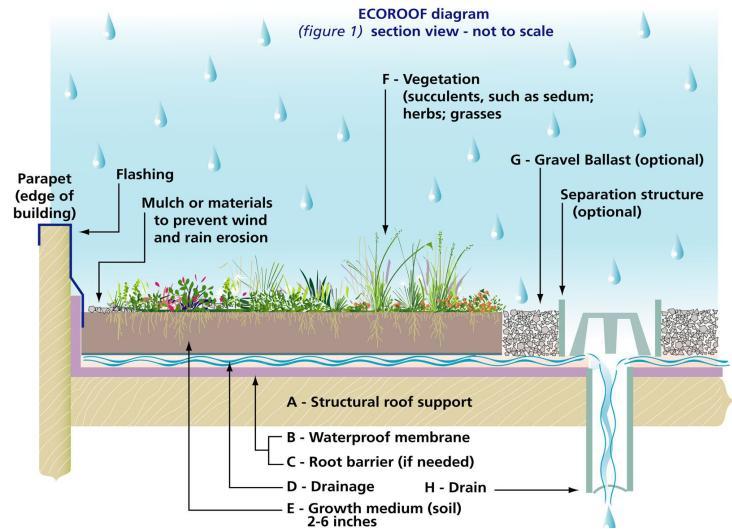
Figure 1. Ecoroof Cross Section

An ecoroof is a living vegetated ecosystem of lightweight soil and self-sustaining vegetation. It is biologically 'alive' and as such provides a protective cover on the building by using the natural elements of sun, wind, and rain to sustain itself. Ecoroofs require little maintenance and provide an aesthetic alternative, with many economic and ecological attributes not found in a conventional roof. Figure 1. shows the main ecoroof components including a waterproof membrane or material that prevents water from entering the building; drainage material such as geotextile webbing that allows water to flow to the drains when the substrate is saturated; and soil or substrate (growing medium) as light as 6 pounds per square foot (psf).

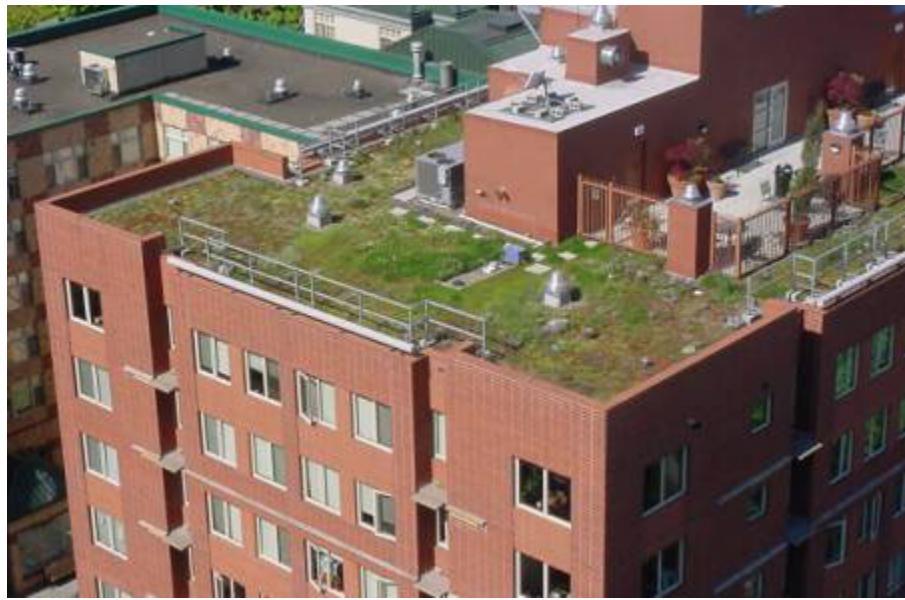
Figure 2. Hamilton East Ecoroof May 2002

The Hamilton Apartments is a ten-story, 8,700 square foot (sf) building. The ecoroof was installed in September 1999. For research purposes, the ecoroof was divided into two sides - east and The east side west. consists of 2520 sf of vegetated cover with initial substrate depth of 3 inches (now 2 inches). The east substrate is 15% composed of digested fiber. 25% encapsulated Styrofoam (EPS), 15% perlite, 15%

course peat moss and 15% compost. Saturated weight of the east substrate is 10 pounds per square foot (psf) for the original 3-inch depth. The west side consists of 2620 sf of vegetated cover with initial substrate depth of 5 inches (now 4-4.5 inches). The west substrate consists of 20% digested fiber, 10% compost, 22% course perlite and 28% sandy loam. Saturated weight of the west substrate is 25 psf for the original 5-inch depth. As of 2003, approximately one inch of substrate was lost on both sides due to wind erosion. An automatic irrigation system with spray heads on 12-inch risers was installed to water during dry periods. The irrigation system was installed to assure plant establishment, the long-term goal is to eliminate the need for irrigation. For example during the summer of 2001, about 6 and 4 inches of water was applied to the east and west sides, respectively; and in 2002 about 3 and 2 inches, respectively).

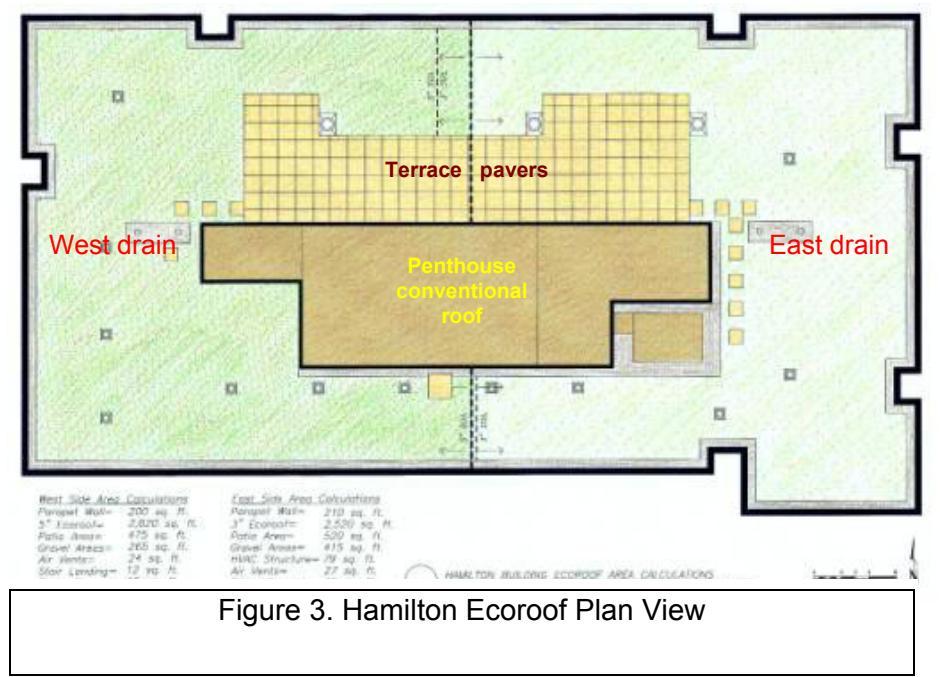
penthouse roof drains into the east ecoroof due to lack of continuous gutters around the conventional roof. See discussion concerning rainfall/runoff discrepancies. Figure 3 shows the roof layout.

As precipitation falls onto the building it flows laterally towards a set of primary and secondary roof drains located near the center of each of the two roof sections. The east drains have a total drainage catchment of 3,811 sf. This east catchment area consists of 2,520 sf of vegetated ecoroof (66%) and 1,291 sf of various impervious surfaces (34% impervious). The west drains have a total drainage catchment of 3,655 sf This catchment area consists of 2620 sf of vegetated ecoroof (72%) and 1,035 sf of various impervious surfaces (28% impervious) For both sides, the various impervious surfaces include vents, parapet walls, gravel on roof membrane, and terrace pavers installed over a 1.5-inch sand base to help absorb moisture.

There is а conventional roof on a 1,239 sf penthouse containing buildina heating and cooling equipment. In December 2001 all downspouts from the penthouse were plumbed directly to the primary roof drains so that conventional roof runoff would not combine with the vegetated areas. However, it is suspected that during high intensity storm 342 events а sf section of the

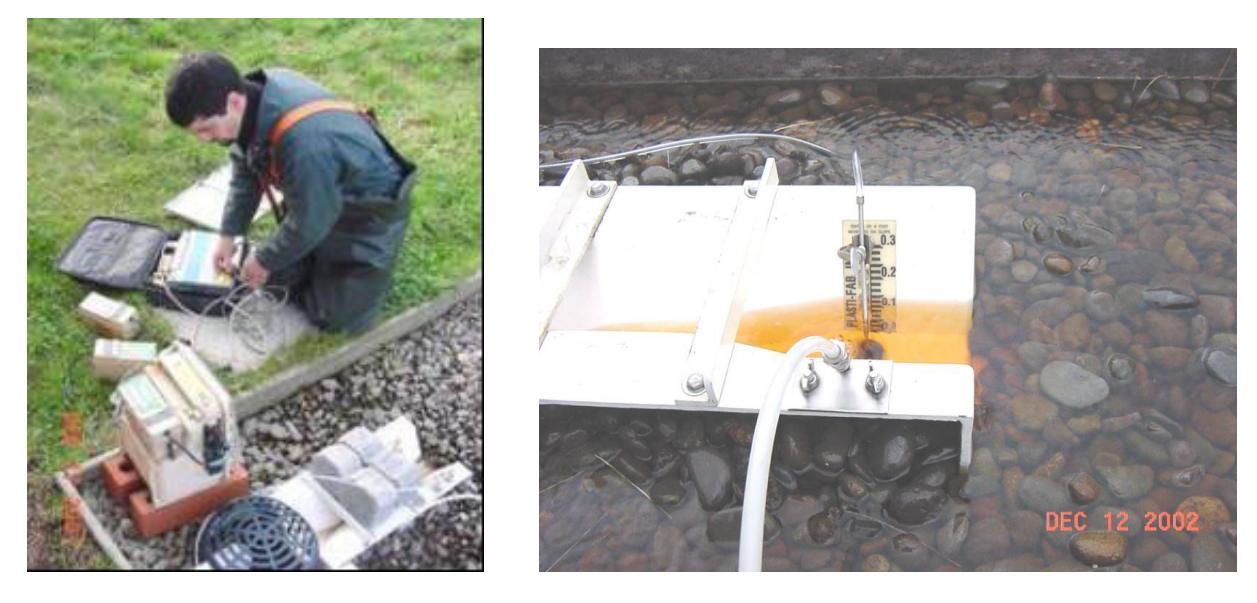
Figure 4. Flow monitoring station photographs. The left shows the flume and flow monitor and the right shows a close-up of the flume during a storm event.

BES Field Operations staff installed flow-monitoring equipment in December 2001. A small, 60degree, V-trapezoidal Plasti-Fab flume is installed adjacent to, and immediately upstream of, each primary roof drain. The primary roof drain is sealed and isolated to direct all flow through the flume prior to entering the drain. An American Sigma Model 950 bubbler-type flow meter is used to measure water level in each flume. Level data are converted to flow values by using a formula created by manually establishing the level to flow relationship specific to these flumes. (Initial monitoring indicated that the formula provided for the flumes by the manufacturer was not accurate enough for this project so BES calculated a more accurate formula).

The primary roof drains are plumbed directly to the City storm sewer system. The adjacent secondary drains are installed as emergency overflow drains if the primary drains become plugged. Since the secondary drains are fitted with a two-inch extension collar, water will only enter the secondary drains if the pooled water level around the drains exceed 2.9 inches on the east side and 2.4 inches on the west side. The possibility exists that during very large storms, some water may flow out the secondary drain and not flow through the flume. (To date, there has been only one storm that created enough runoff to cause overflow to the west secondary drain.) The secondary drains discharge directly off the side of the building. Drainage from the conventional roof enters the primary drains immediately downstream from the flume outlets and is not monitored.

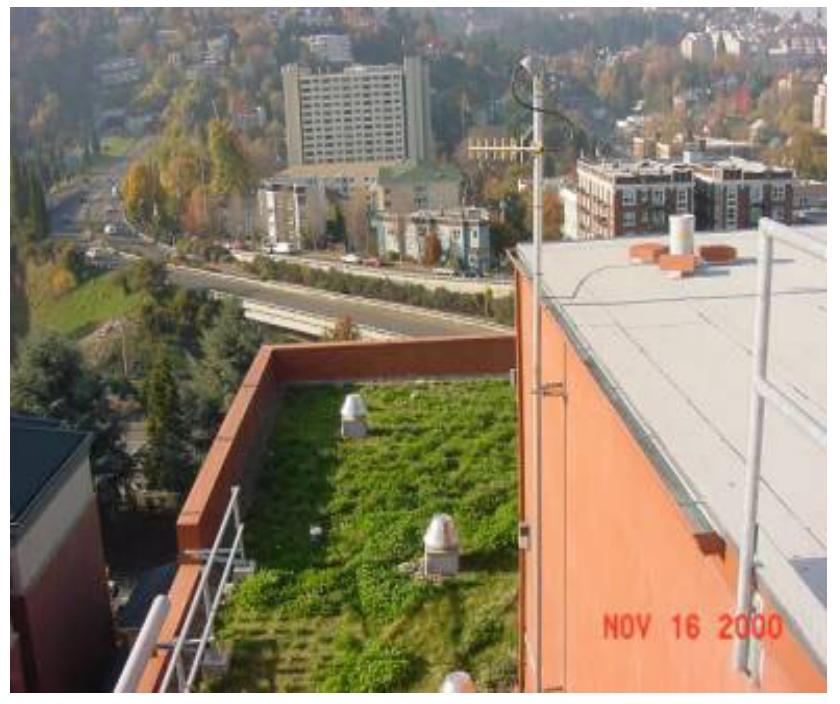
Figure 5. Rain gauge and antenna in upper right.

А Hydrological Services tipping bucket rain gauge is installed atop the conventional roof in the center of the building ensure that to accurate data rain are collected for the site. Rain data are collected and relayed via radio telemetry to a networked computer (HYDRAsystem). Rain data are converted to a rain run-on flow rate for side each by multiplying rainfall by the catchment area.

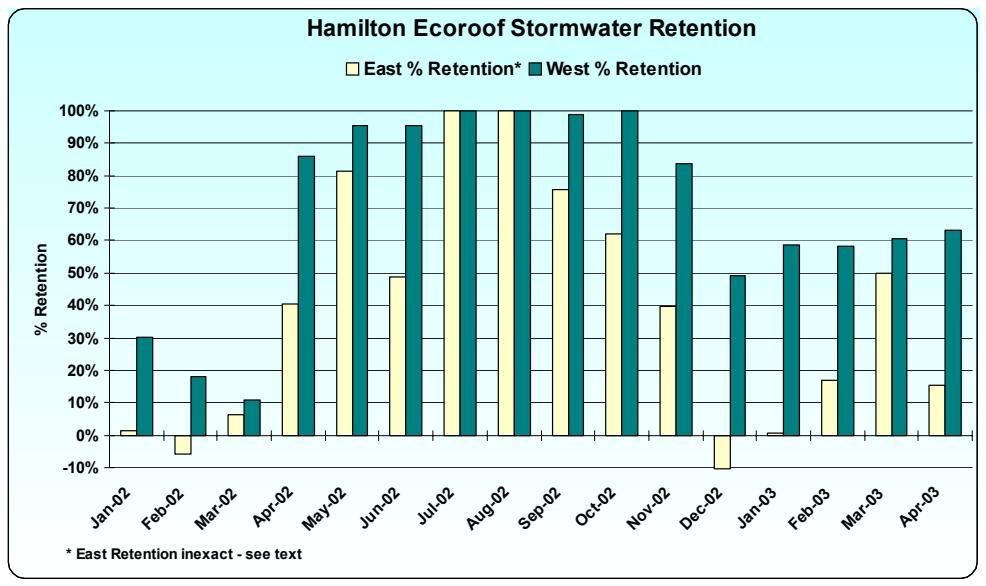
The flow attenuation characteristic of each ecoroof was evaluated by comparing rain run-on to runoff to calculate retention. In general, both ecoroofs retained varying amounts of stormwater relative to seasonal influences as shown by Figure 6. However, more runoff than run-on was measured during certain months for the east side. After eliminating potential equipment malfunctions, this discrepancy is attributed to unmeasured run-on flow that comes from a 342 sf section of the conventional roof on the penthouse. We believe this is caused by high intensity storms where the flows bypass the penthouse's non-continuous gutter system and cascades onto the east ecoroof. Due to this discrepancy, only the west rain and flow data will be evaluated here.

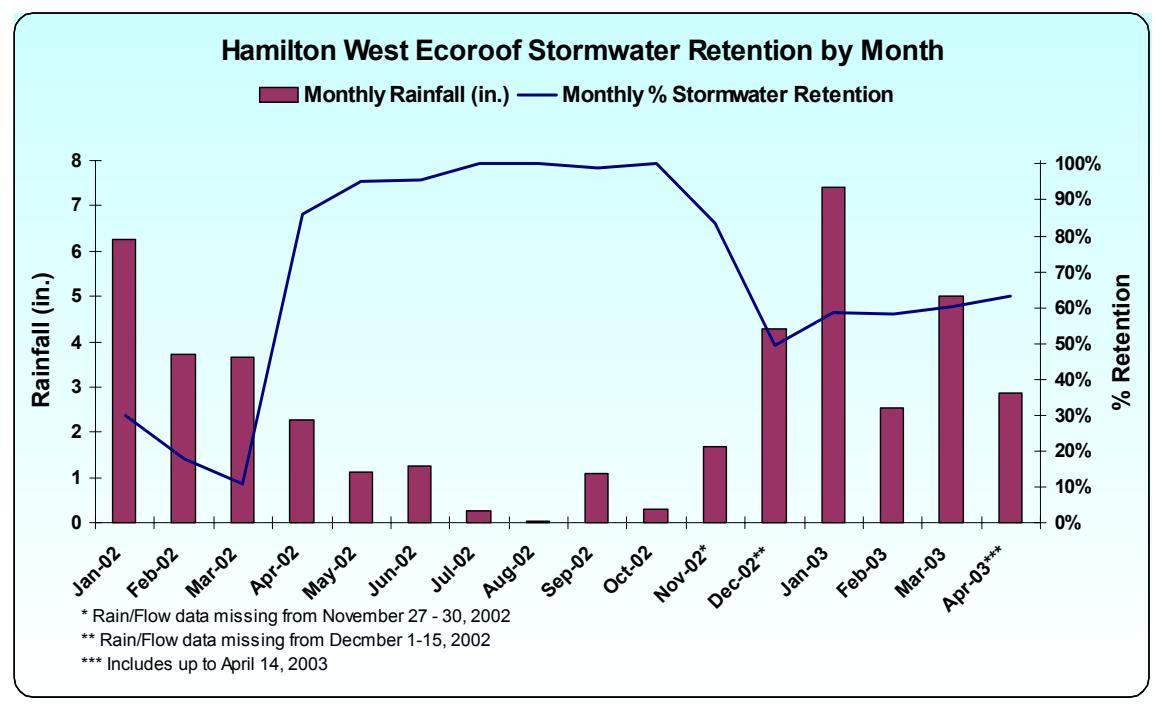
West ecoroof retention is shown in Figure 7 for the 15-month monitoring period. Rainfall retention has been calculated using the difference between the rain run-on and runoff volumes. The retention for the west ecoroof during this period is an impressive is 69%, which appears to be increasing with time. This apparent increase in retention can be observed by comparing the retention for Jan-March 2002 with Jan – March 2003.

Figure 7 Hamilton West Ecoroof Retention by Month

The west ecoroof had significantly different retention rates for the months of January, February and March of 2002 and 2003. It is likely there are several factors contributing to the difference in retention from one year to the next. Some factors may include rainfall distribution and intensity patterns, air temperature, vegetation/substrate ecosystem maturity, and perhaps human influences.

The January to March 2002 rainfall retention for the west ecoroof was 20%, and for the same period of 2003 the retention was 59%. The two periods have similar total rainfall amounts of 14.3 and 13.13 inches for 2002 and 2003, respectively. However, the rainfall patterns for the two years are different. 2003 has a greater variability of rainfall and 2002 has more even rainfall distribution. This can be seen in Fig. 8. Note the long dry periods between storms in 2003 and the relatively even rainfall for the same period in 2002. The long dry periods may account for greater evapotranspiration and increased water holding capacity in the ecoroof. 2002 does have some long dry periods as well near the end of February and March. Interestingly, 2002 has 40 dry days and 2003 has only 39 for the three-month period.

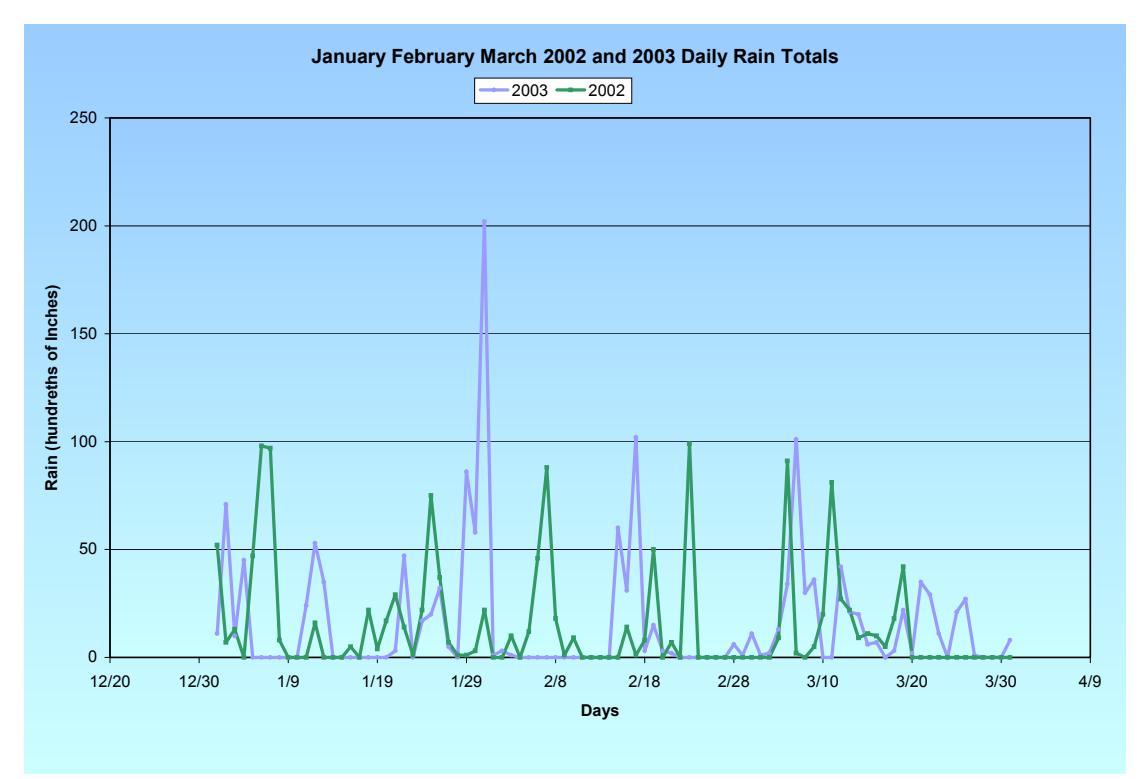
Figure 8. Daily Rainfall for January, February and March – Years 2002 and 2003

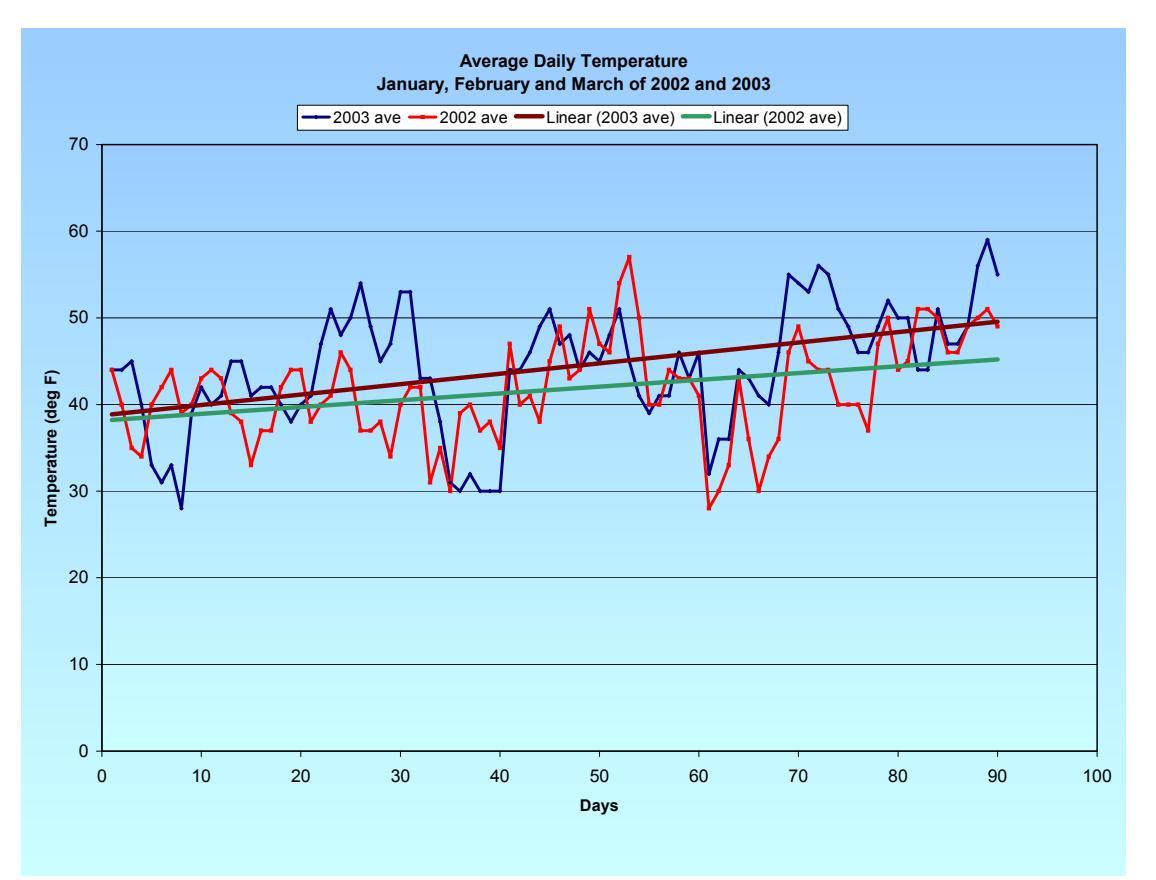
The daily average temperatures for the three months in 2002 and 2003 are plotted in Figure 9. It's difficult to see any pattern in the data, until a linear best-fit line is added. This clearly shows

the average daily temperature in 2003 was higher than in 2002 for the same period. The average daily difference was 2.4 degrees Fahrenheit. The effect of this temperature difference and the potential evapotranspiration may account for the higher 2003 retention rates. The last, and potentially most significant, factor that contributed to the increased retention between 2002 and 2003 is the vegetation maturity.

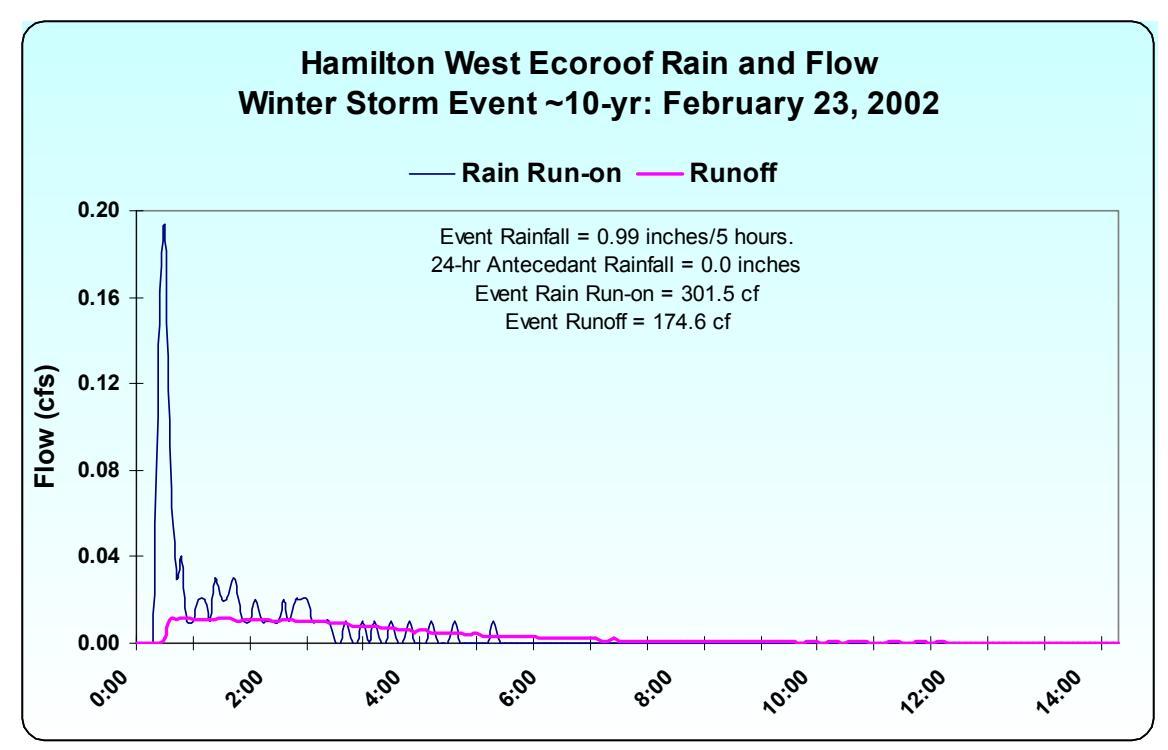
Figure 10. High Intensity, Short Duration Winter Storm.

The following four figures show retention relative to specific storm events of varying intensities and times of year. Peak rainfall intensities for the storms shown on Figures 10-13 range from 0.041 to 0.193 cfs for rain run-on, whereas corresponding peak runoff flows range from 0.008 to 0.012 cfs . Even when the substrate is saturated, the ecoroof system attenuates the intense run-on peaks of even the largest winter storms. Notice how the runoff flows seem to stay relatively flat when the peaks occur. Figure 10 shows a very intense winter downpour, where the peak runoff is 1/16th the peak run-on. For a similar event Figure 11 shows that a very intense peak is almost totally attenuated by the ecoroof. Figure 12 shows a large storm, about equivalent to a 2-year/ 24-hour event typical of Portland in that it does not necessarily have an intense peak. Figure 13 shows a somewhat common winter storm after a series of preceding days with rainfall. Peak intensities for the Feb 2002 and Sept 2002 storms are much more intense.

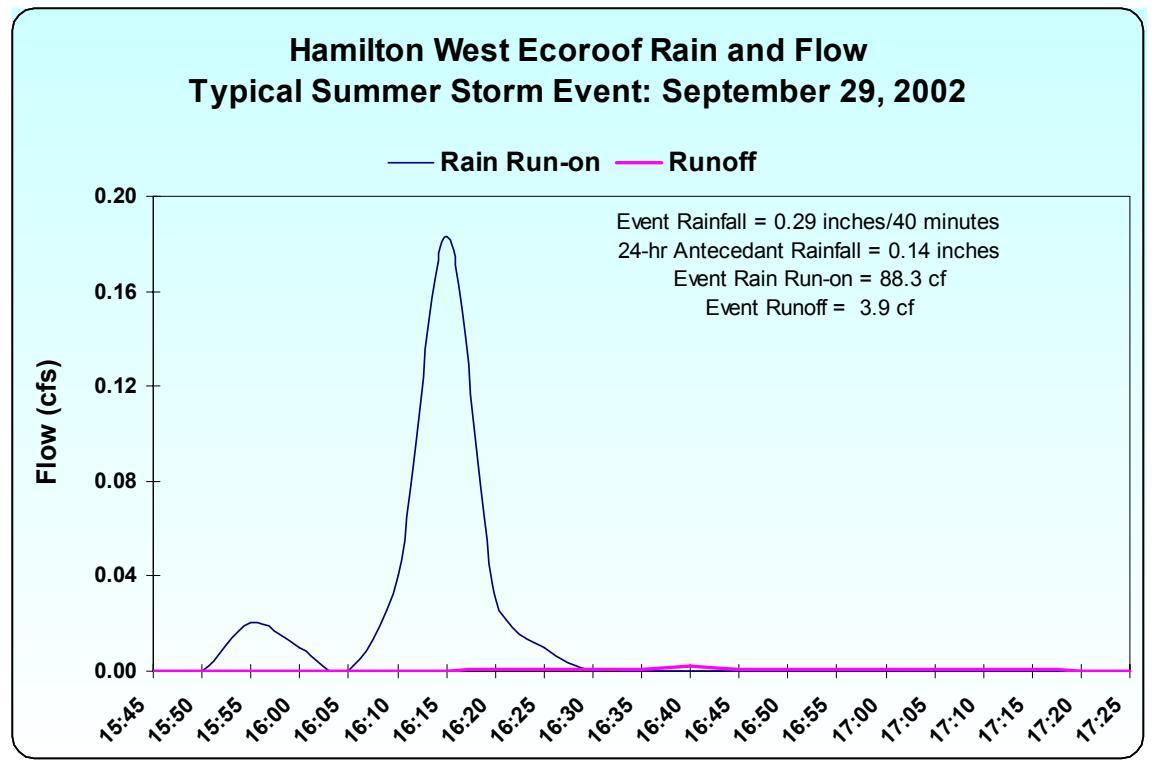
Figure 11. High Intensity, Short Duration Summer Storm

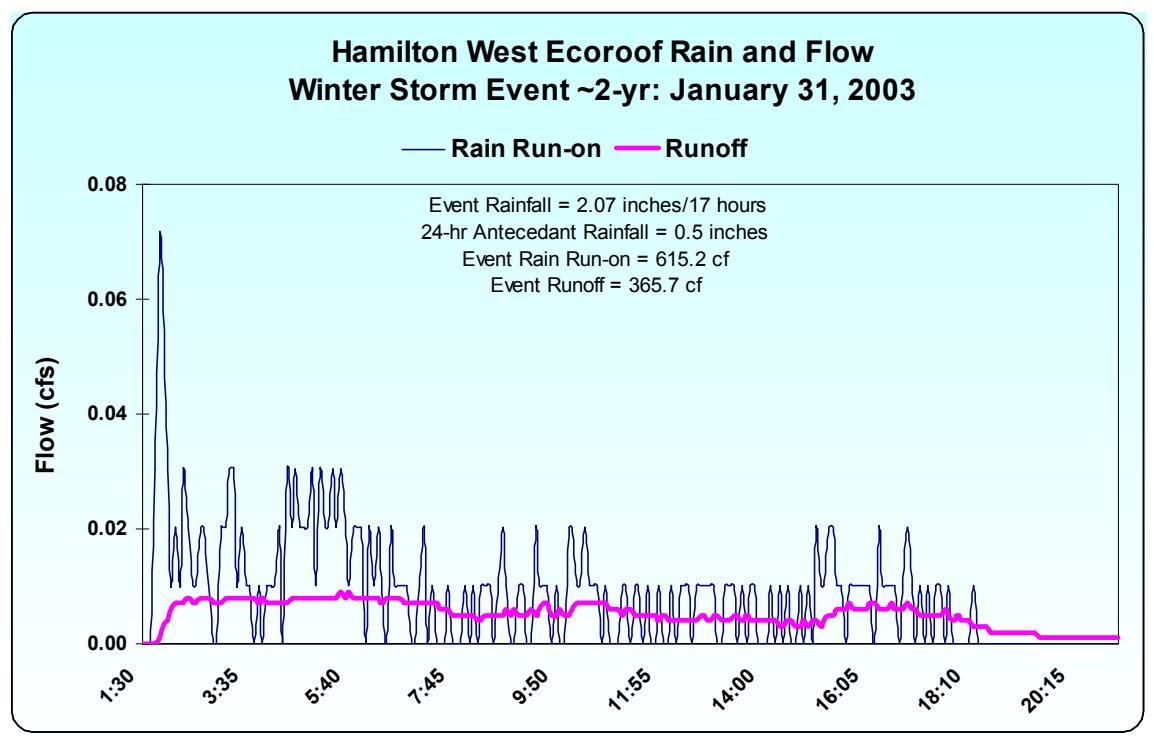
Figure 12. Low Intensity, High Volume Winter Storm

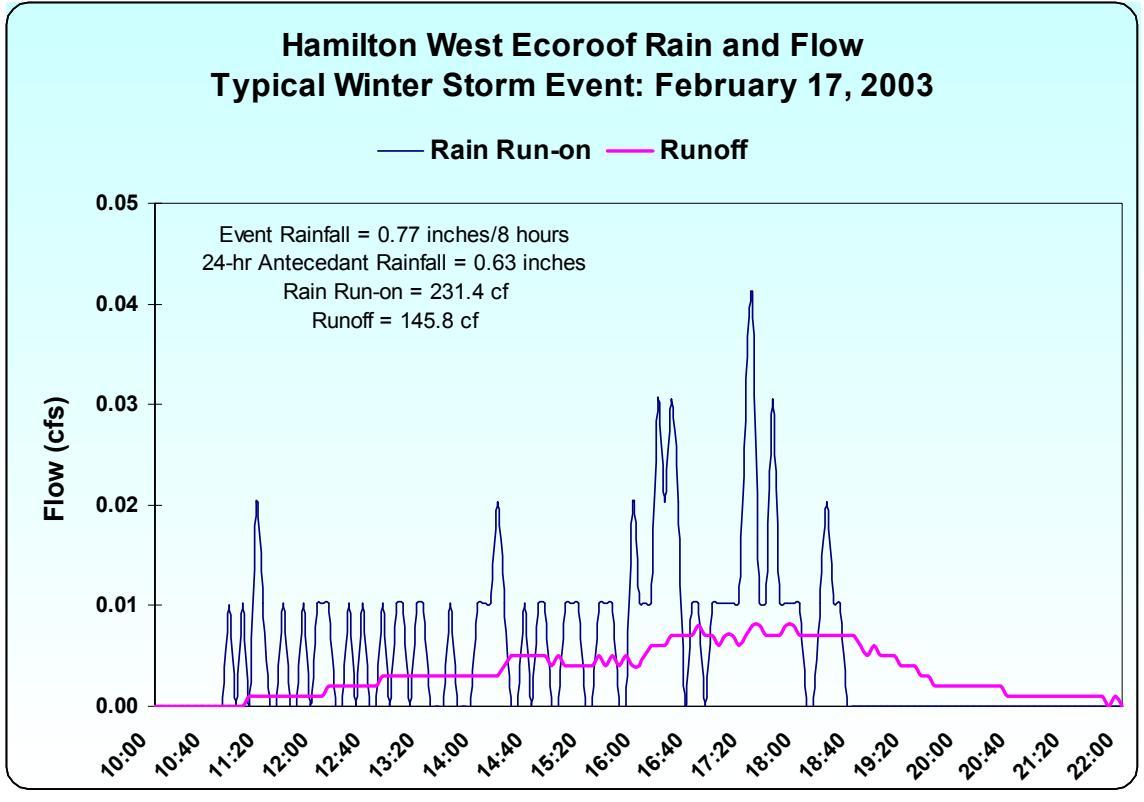
Figure 13. Low intensity, Low Volume Winter Storm

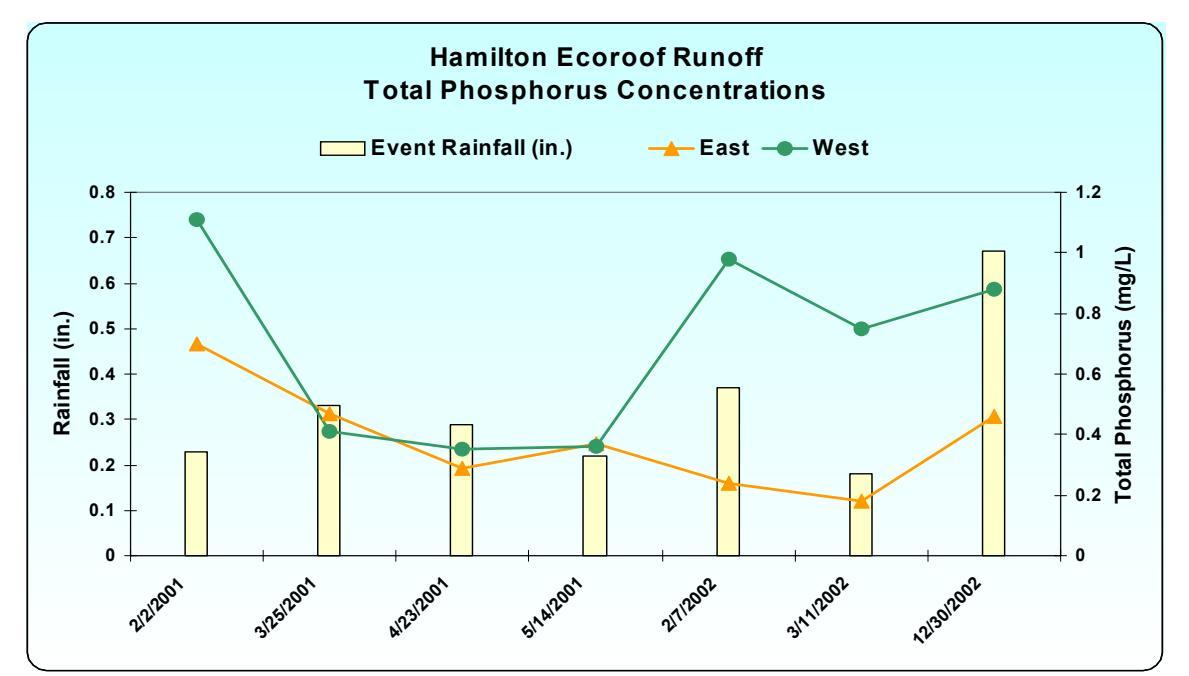
Figure 14. Total phosphorus concentrations in runoff from both the east and west ecoroofs.

Figures 14 and 15 show constituents such as total phosphorous (TP) and ortho-phosphorous at concentrations above Oregon receiving water standards. Note the difference between east and west ecoroof flow concentrations and the substrate chemical composition shown in Table 2. In Oregon, phosphorous concentrations are considered of most concern during the dryer months May-October. It appeared that over time phosphorus levels might be coming down, until the last 3 events as shown in Figures 14 and 15. However it appears from the data that warmer months such as April and May have the lowest concentrations. BES may attempt to gather additional warm weather data from these ecoroofs or may move to monitoring other ecoroof installations.

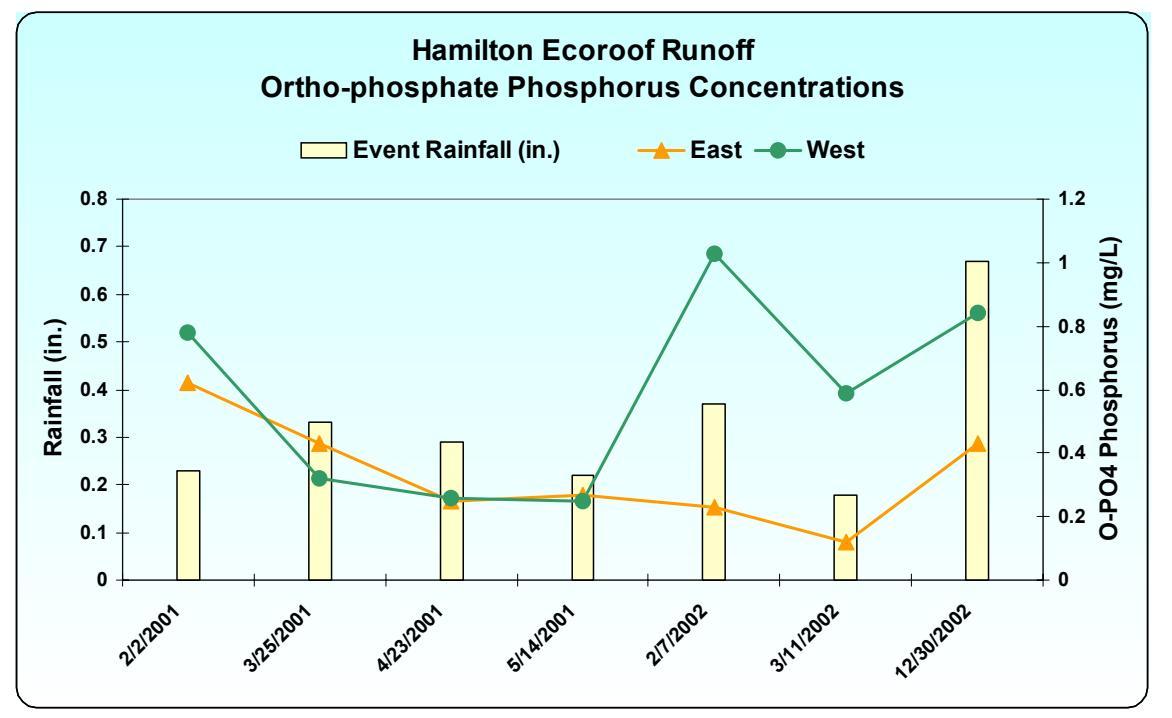
Figure 15. Orthophosphate concentrations in runoff from both the east and west ecoroofs.

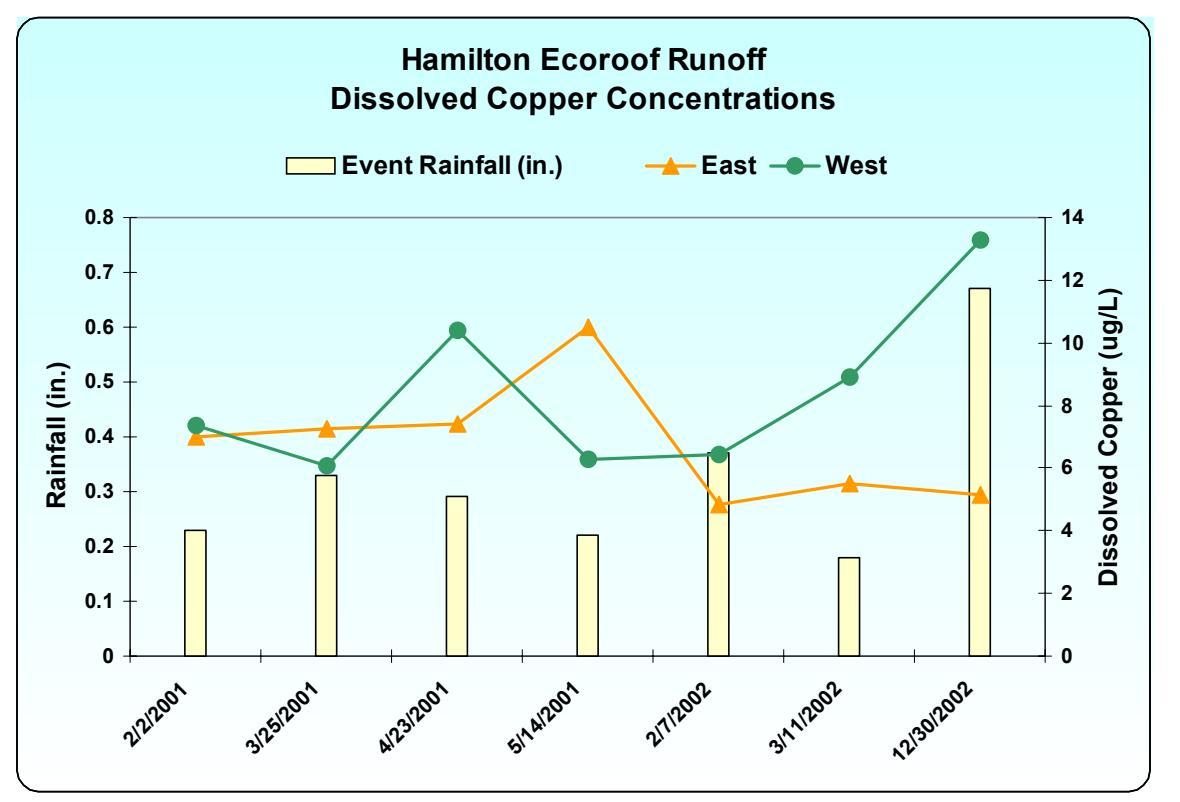
Figure 16. Dissolved copper concentrations measured in runoff from both the east and west ecoroofs. Most samples (11 of 14) were below acute water quality criteria of 0.9 ug/l at a hardness of 50 mg/l.

Figure 16 shows dissolved copper concentrations which, based on water hardness, are usually below in-stream standards. However, 3 of the 14 samples were above the criteria, two in the warmer months and one in winter 2002. Numerous factors will be considered to determine the cause of these issues. But again, attention to substrate ingredients and materials to be used on the ecoroof can affect these parameters. For example, the roofing industry uses an abundance of galvanized metals, copper and lead. A potential source for copper on the Hamilton building could be the treated lumber the landscape contractor used for edging material. Background levels in the west ecoroof may be high due to the natural topsoil mixed with the substrate. However, as pointed out above, the copper loadings would be much reduced because the warm weather flows are almost zero. One option that should be evaluated in reducing pollution from all roofs is the types of roofing materials that are allowed. Several projects in Southern California (Crystal Cove, Newport Beach for example) have restrictions on copper and zinc containing materials being used for roofs, gutters, and downspouts.
